Manhole Inspection Summary

Manhole # S53O__002MH

Insp Date: **4/16/08 1:37 PM**

Location Address: **1201 south east av**

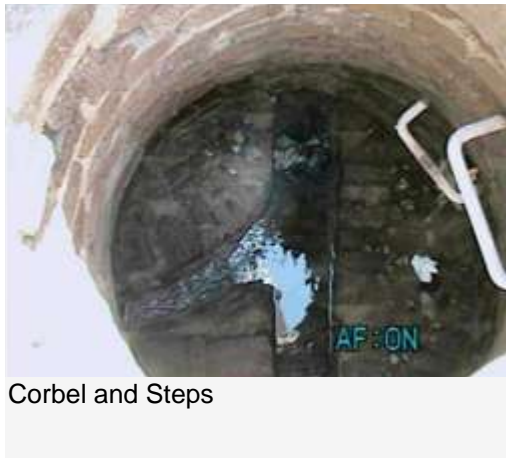
Defect 2

Condition: ☐ Sound ☐ Cracked ☐ Root Intrusion ☒ **Loose Brick** ☐ Deteriorated

Count: **3** Missing: **0** ☒ **Corroded**

Corbel and Steps

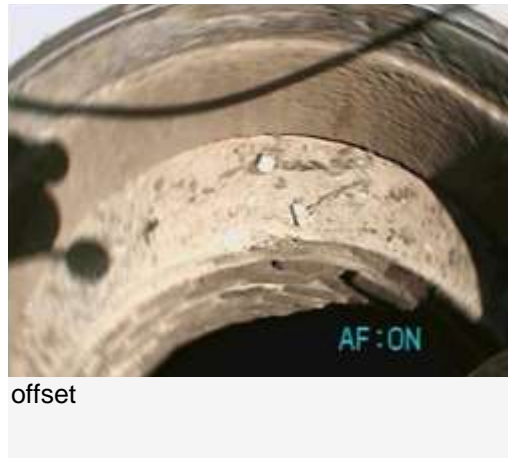
Defect 1

Offset: **6** (in.)

offset

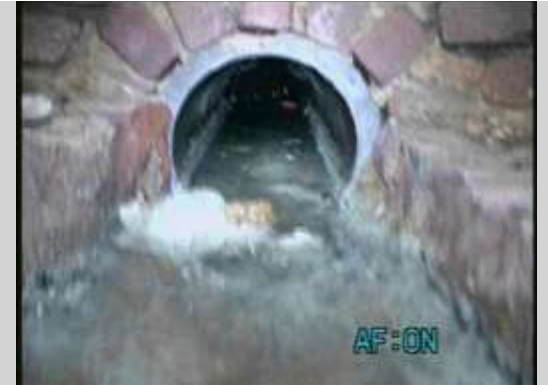
12 O'Clock Outflow

8 in. Circular Gravity Sewer
Pipe Out @ 12 O'Clock

Pipe Material: **Clay** ☐ Pipe Lined

Invert Depth: 6.50 (ft.) Flow Characteristics: **Slow**

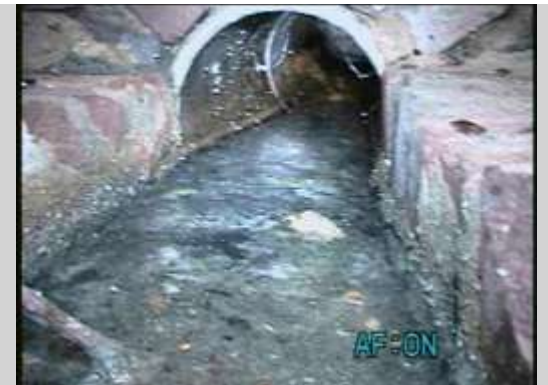
6 O'Clock Inflow

8 in. Circular Gravity Sewer
Pipe In @ 6 O'Clock

Deposits: ☐ None ☐ Mud ☐ Sludge ☒ **Debris** ☐ Grease

Silt Depth: 2 (in.) Deposits Extent: **Medium**

Connects To: **House connection / Service line**

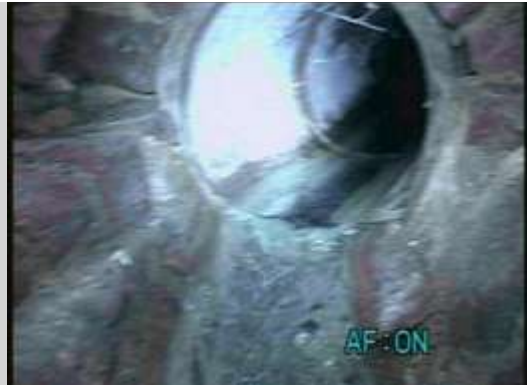
9 O'Clock Inflow

8 in. Circular Gravity Sewer

Pipe In @ 9 O'Clock

Invert Depth: **6.10** (ft.) Flow Characteristics: **Slow**
